By Brian Rhodes, P.E.

Structure Background

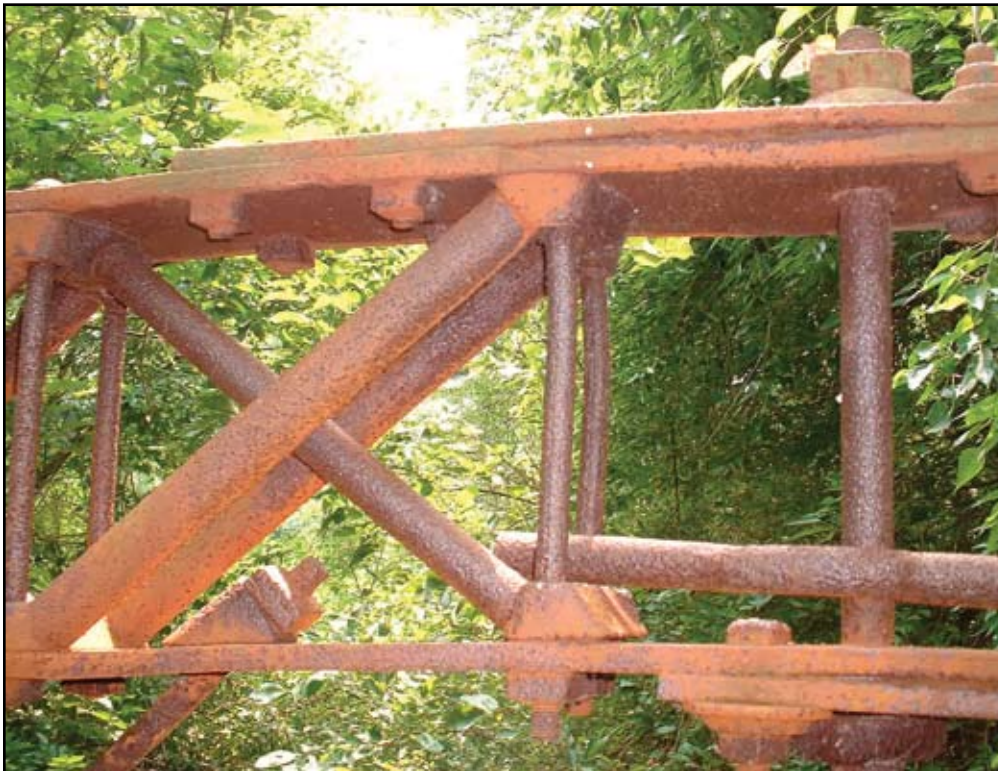
Figure 2: Arch detail at mid-span splice prior to rehabilitation.

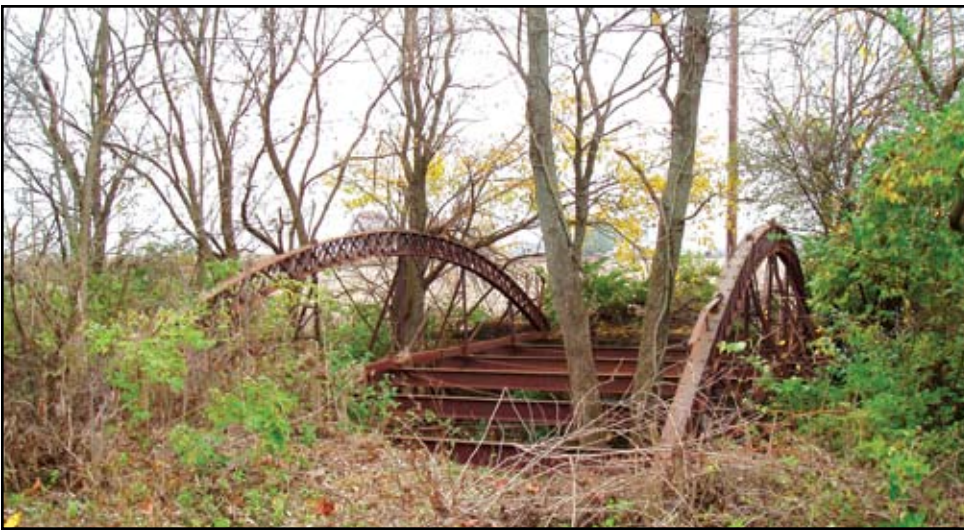
Figure 3: Structure as discovered adjacent to Oxford Road.

The first phase of the structural evaluation and design involved a detailed inspection of the existing bridge. No maintenance had been performed on the bridge, no deck was in place, heavy vegetation and full size trees were growing between the floorbeams, and some members were missing (Figure 3). Of particular interest, the external bracing was missing at one of the floorbeams, and the railings, once located at the four bridge corners, were mostly gone. Parts of one of the railings remained, offering a glimpse as to what the original railing may have looked like. Many of the members had failed. The diagonal bracing connection at each floorbeam had failed in two locations. The hollow compression tubes that make up the arch section were mostly in tact. It was obvious, however, that during the sandblasting required for rehabilitation, additional deterioration would be revealed that was not readily visible in the field.

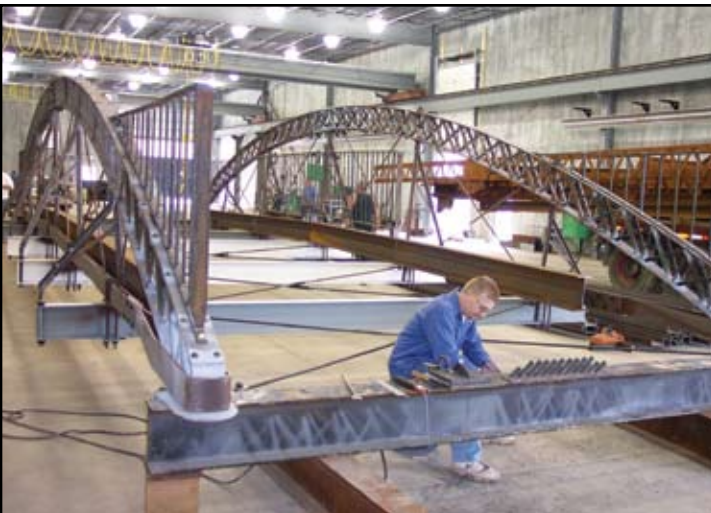
Figure 4: Bridge under rehabilitation at Ohio Bridge Corp.

The contractor awarded the job of arch rehabilitation and construction was the Ohio Bridge Corporation of Cambridge, Ohio. This company has a background in historic bridge restoration, making them a perfect fit for this project. Tom Brayshaw noted, "Ohio Bridge seemed to take real pride in restoring historic bridges." As with any restoration, the preferred option is to save the original bridge components. For bridge components where this was not possible, Ohio Bridge fabricated new steel pieces. Ohio Bridge also fabricated the railing to be placed on the bridge. The original structure had only remnants of bridge railing at each corner. To meet code, a new railing would need to be fabricated for the entire structure length. The new railing was designed and detailed to resemble the makeup of the original railing, while still meeting code requirements for clear openings (Figure 4).

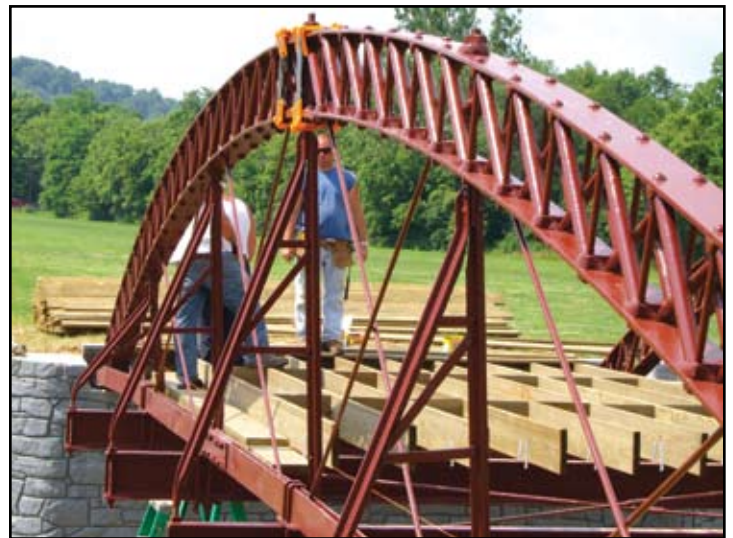
Figure 5: Relocated bridge receiving deck.

The bridge was trucked to the new site, and dropped into place. Timber stringers, decking, and blocking were placed on top of the floor-beams (Figure 5). A timber curb on each side provided a place to mount the new railing (Figure 6). The bridge was dedicated on September 16, 2006. The structure received a County Engineers Association of Ohio Historic Preservation Award, and is being considered for others. ■

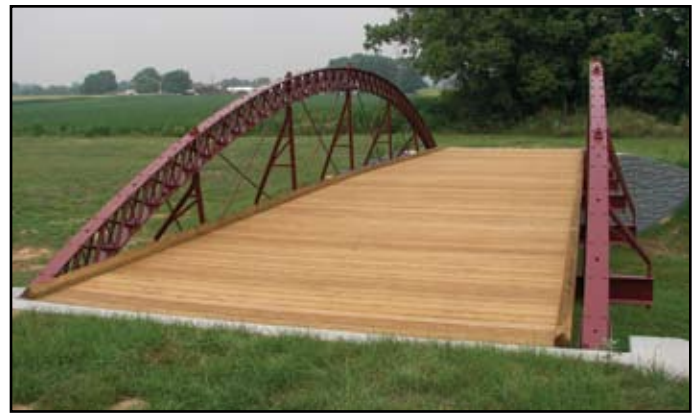
Figure 6: Relocated bridge prior to trail construction and railing installation.
